FLEX-MAT®

HIGH VIBRATION WIRE SCREEN

APPLICATION CASE

MANGANESE ORE > Australia

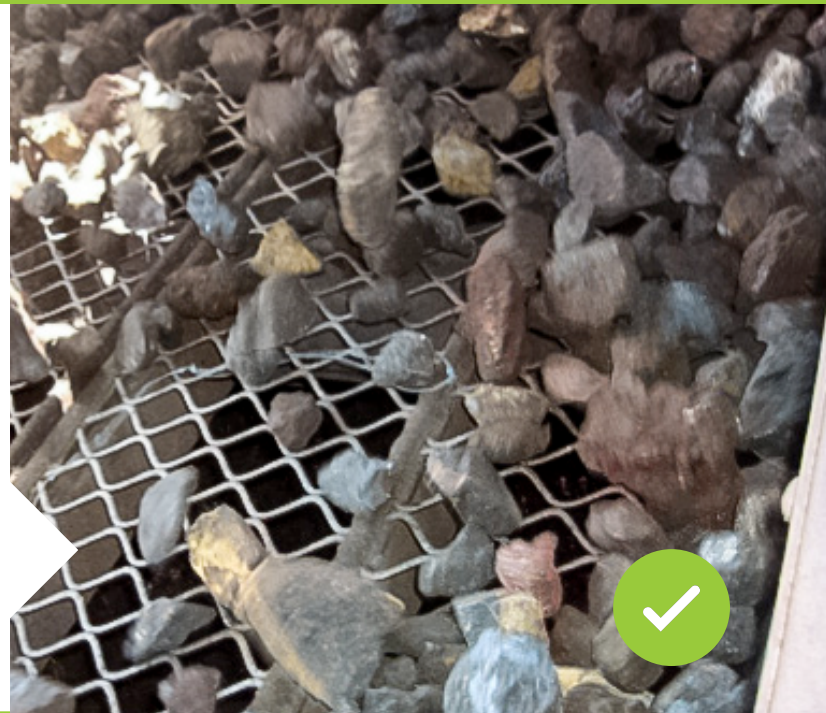
Switched to **Flex-Mat Type D** with 2½" (63mm) opening.

- Eliminated pegging and downtime.
- Reduced oversize material.
