HIGH VIBRATION WIRE SCREEN

APPLICATION CASE STUDY

LIMESTONE, HNG SCREENER > Europe

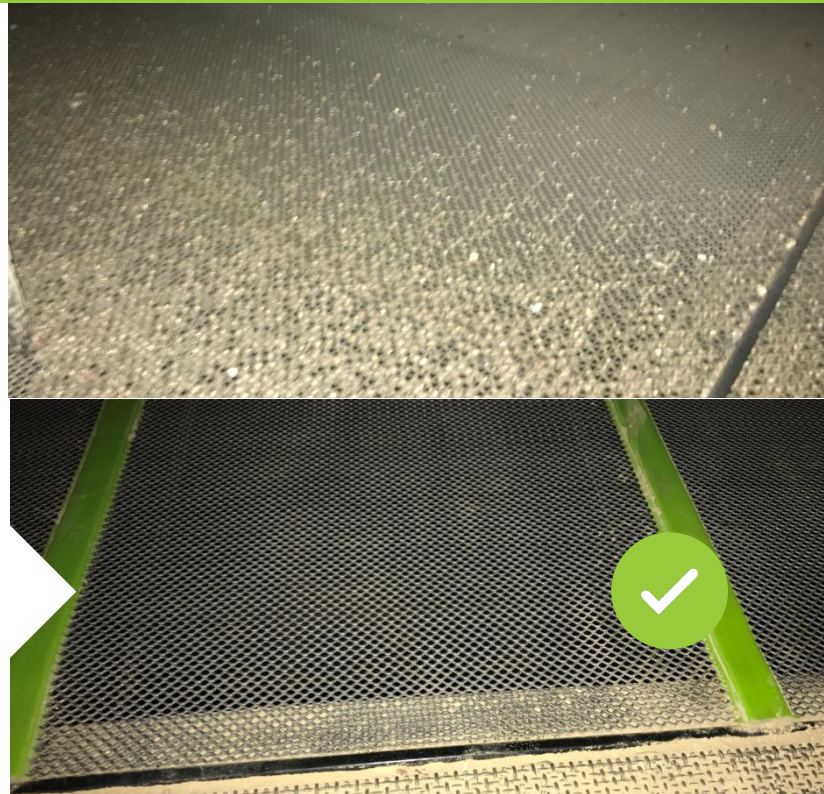
The plant switched to Major's FLEX-MAT D Series screens, replacing the woven square mesh screens. This change resolved pegging issues and significantly improved the wear life of the screens.

- > **Resolved Pegging Issues:** The FLEX-MAT screens eliminated the pegging problems, allowing continuous operation without frequent cleaning shutdowns.
- > **Improved Material Quality:** The consistent performance of the FLEX-MAT screens ensured higher and more reliable material quality.
- > **Extended Wear Life:** The wear life of the screens doubled compared to the previous woven square mesh, reducing maintenance and replacement costs.
