## HIGH VIBRATION WIRE SCREEN

### APPLICATION CASE

#### MANGANESE ORE > Australia

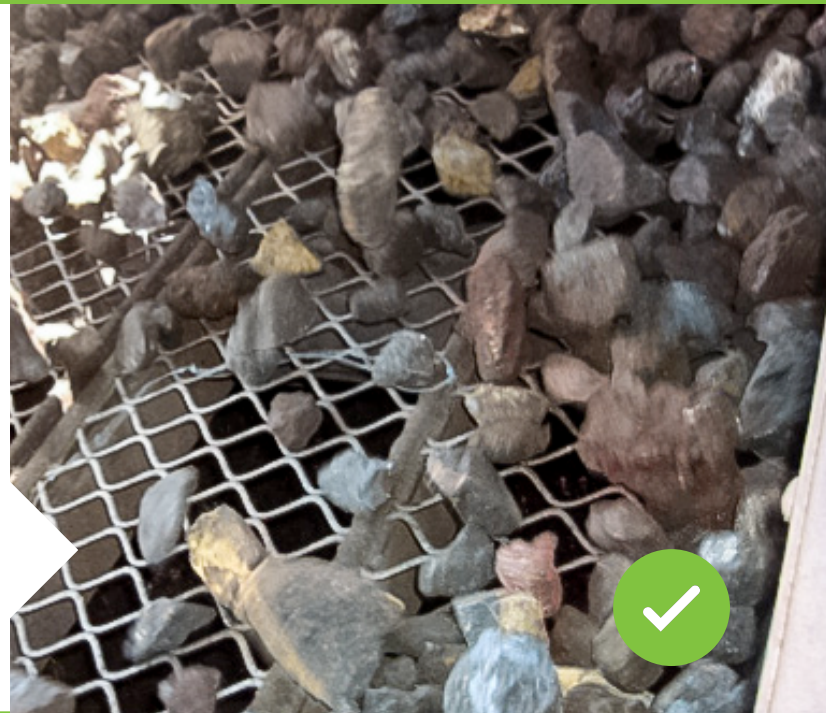
Switched to **Flex-Mat Type D** with 2½" (63mm) opening.

- Eliminated pegging and downtime.
- Reduced oversize material.
