## HIGH VIBRATION WIRE SCREEN

### APPLICATION CASE STUDY GRANITE SCREENING > Europe

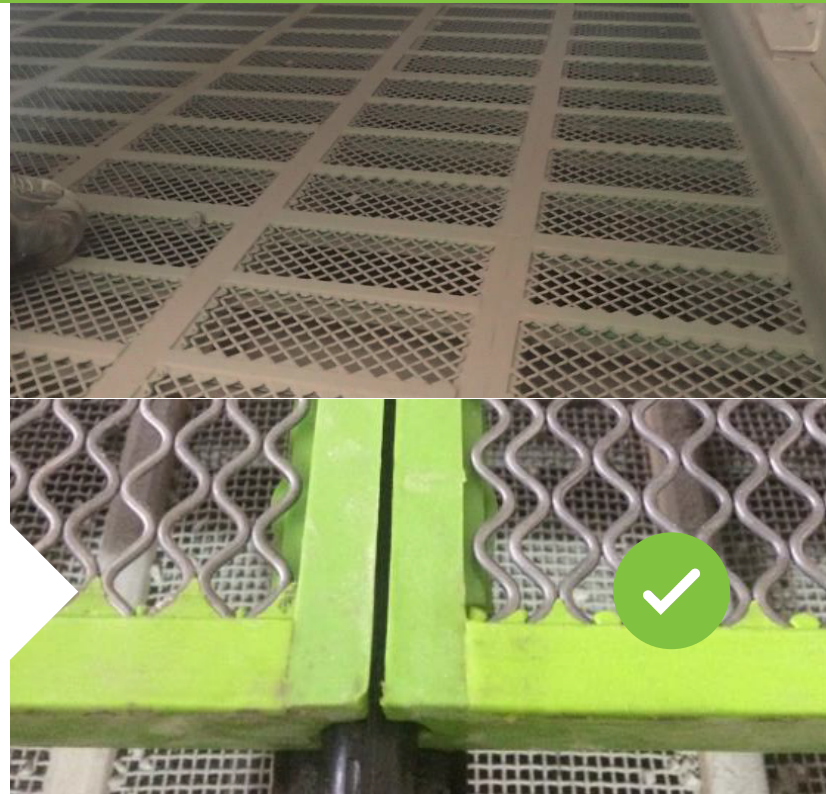
The plant switched to Major's FLEX-MAT Modular D Series with Optimum Wire. This change eliminated pegging and clogging issues, allowing the plant to operate for extended periods without needing to clean the screens.

- > **Increased Capacity:** The plant experienced a 20% increase in capacity compared to polyurethane screens.
- > **Eliminated Cleaning Requirements:** The new screening system removed the need for frequent cleaning, allowing continuous operation.
- > **Extended Wear Life:** Screen wear life increased from 250 hours to 1100 hours compared to polyurethane screens, significantly reducing maintenance and replacement costs.
