## HIGH VIBRATION WIRE SCREEN

### APPLICATION CASE STUDY

#### LIMESTONE, HNG SCREENERS > Europe

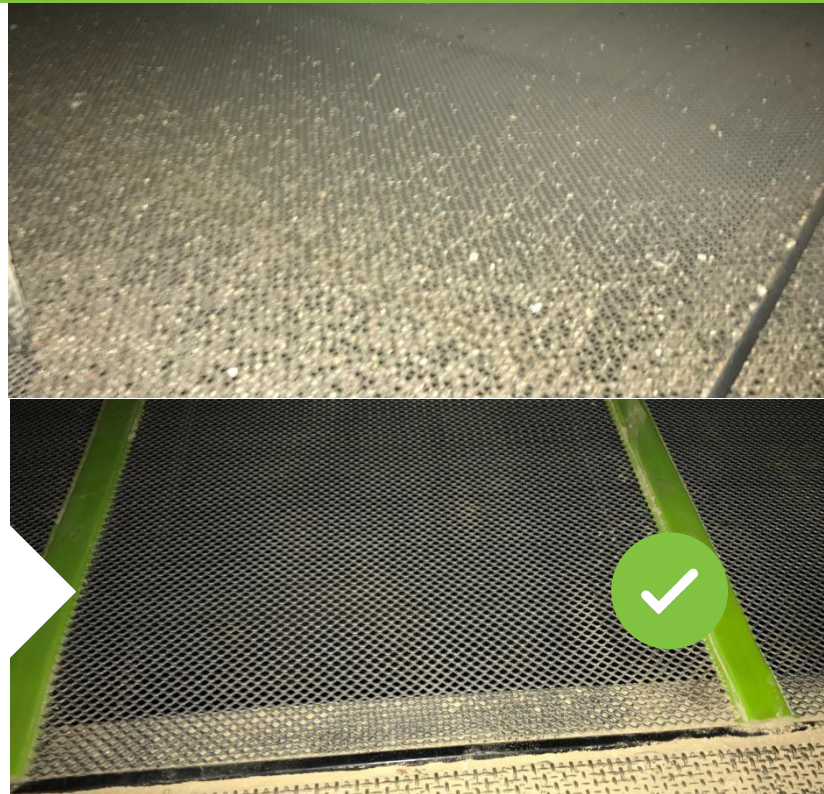
The plant switched to Major's FLEX-MAT D Series screens, replacing the woven square mesh screens. This change resolved pegging issues and significantly improved the wear life of the screens.

- > **Resolved Pegging Issues:** The FLEX-MAT screens eliminated the pegging problems, allowing continuous operation without frequent cleaning shutdowns.
- > **Improved Material Quality:** The consistent performance of the FLEX-MAT screens ensured higher and more reliable material quality.
- > **Extended Wear Life:** The wear life of the screens doubled compared to the previous woven square mesh, reducing maintenance and replacement costs.
