## HIGH VIBRATION WIRE SCREEN

### APPLICATION CASE

SAND AND GRAVEL > Idaho, USA

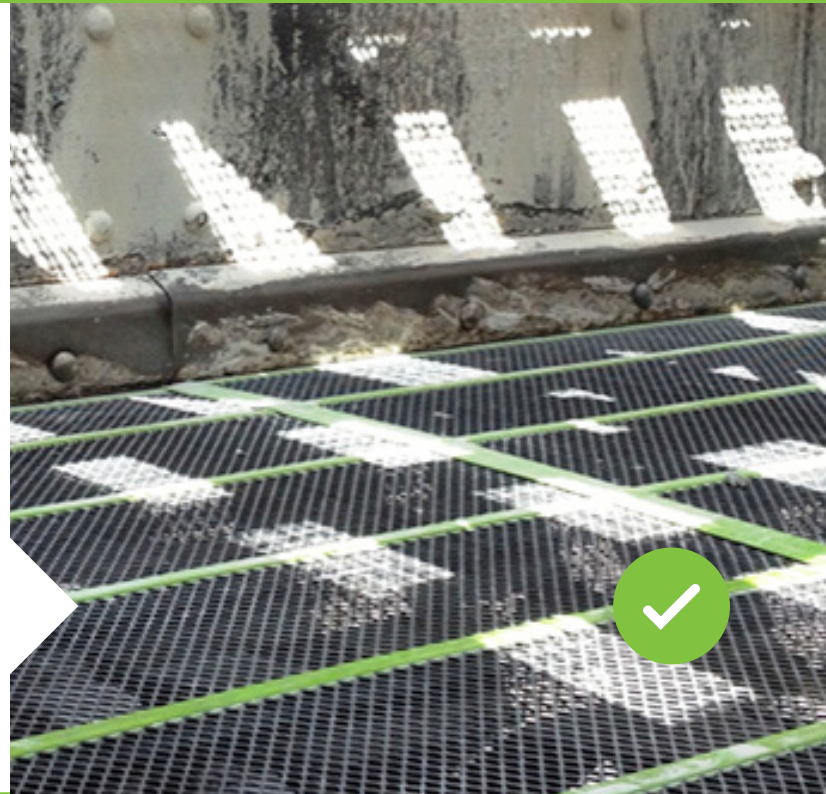
Switched to **Flex-Mat Type D** with 3/8" (9.5 mm) opening.

- Solved blinding by eliminating the root cause of the problem, the woven screen.
- Increased productivity.
- Screen life increased.

- > Flex-Mat increased wear life from 4 months to 6 months.
- > Increase of sand production from 1600 tons to 2000 tons per day.
