## HIGH VIBRATION WIRE SCREEN

### APPLICATION CASE

**NATURAL AGGREGATE** > *British Columbia, Canada*

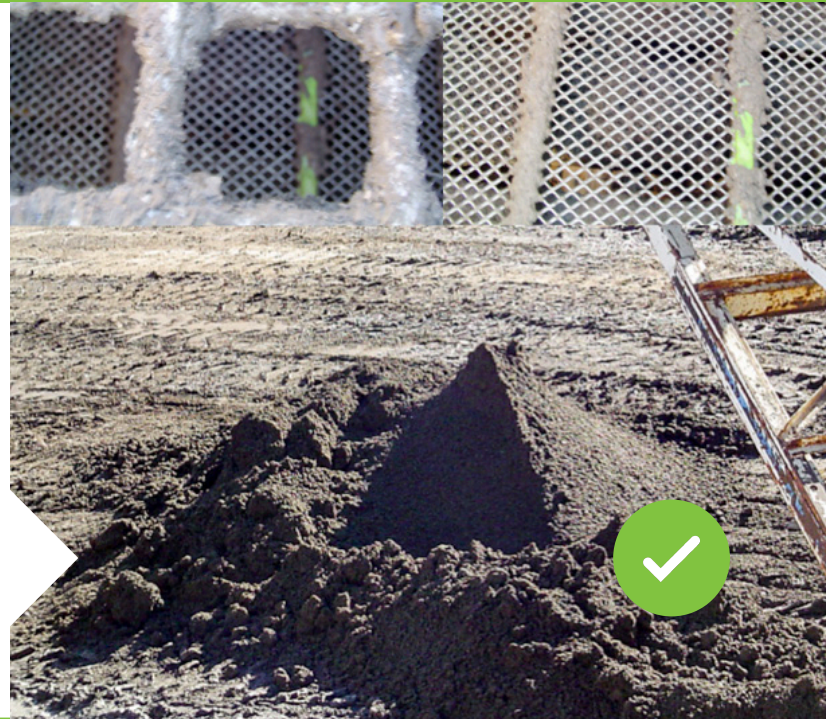
**Flex-Mat Type D** was installed with 1/2" (12.7 mm) opening in stainless steel.

- Eliminated pegging and clogging.
- 100% increase on wet days.
