FLEX-MAT®

HIGH VIBRATION WIRE SCREEN

APPLICATION CASE

SAND AND GRAVEL > Idaho, USA

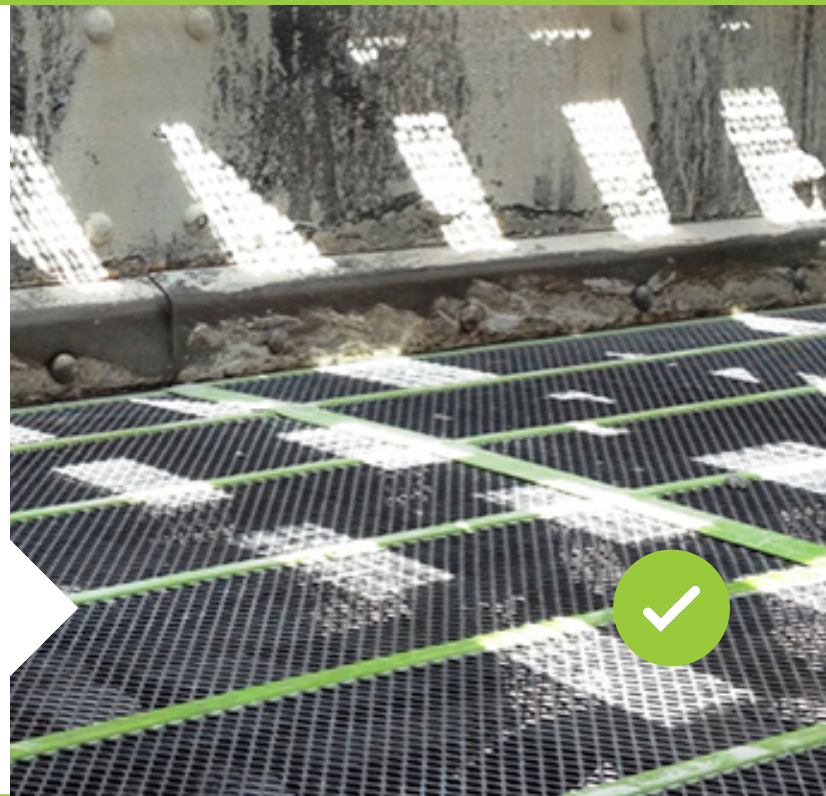
Switched to **Flex-Mat Type D** with 3/8" (9.5 mm) opening.

- Solved blinding by eliminating the root cause of the problem, the woven screen.
- Increased productivity.
- Screen life increased.
