## HIGH VIBRATION WIRE SCREEN

### APPLICATION CASE

#### GRANITE AGGREGATES > Virginia, USA

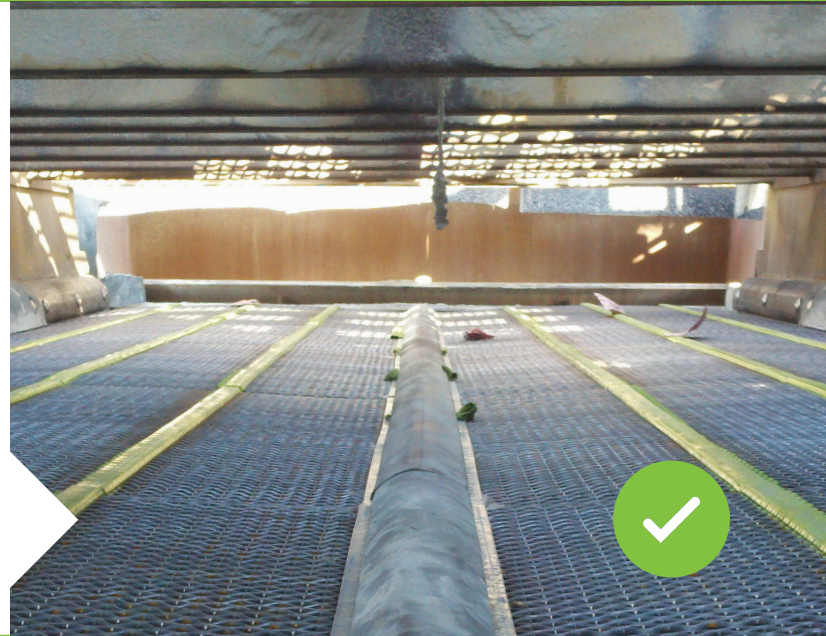
Installed Major's **Flex-Mat Type D**, eliminating pegging and blinding of the middle deck.

- > **Flex-Mat helped the quarry achieve approximately 450 TPH** of base production *versus* an initial base production rate of 150 TPH.
- > **No quality issues** on cleanliness for flats & elongated. The operation ran base products with SMA products (extreme flats & elongated sensitive).
- > **The operation plant was set up to run stone matrix asphalt (SMA)** products which are extremely sensitive to flats & elongated particles.

- > **Flex-Mat tripled** the productive operational life of the middle deck media *versus* woven.
